RECYCLING AND WASTE DISPOSITION SUBCOMMITTEE

MEETING SUMMARY

WIPP Underground Fire Accident Investigation Summary February 5, 2014

WIPP Underground Radiological Event Investigation Summary February 14, 2014

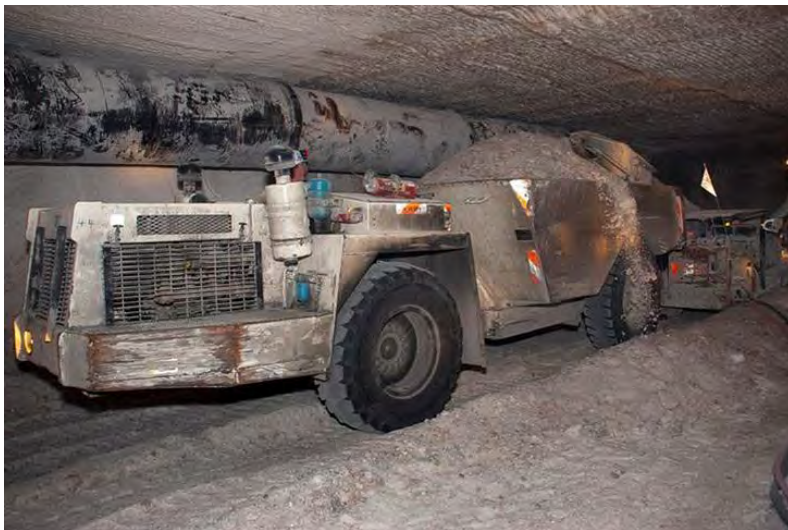
On February 5, 2014, at approximately 11:00 AM, the Waste Isolation Pilot Plant in Carlsbad, New Mexico suffered an underground fire in a salt hauler vehicle. There were 86 people in the mine at the onset of the fire, all exited the mine safely. Six personnel were transported to the Carlsbad Medical Center for smoke inhalation and an additional seven personnel were treated on-site.

The EIMCO Model 985, 15 ton haul truck is a diesel powered vehicle used to haul salt from the mine. This is an aged piece of equipment, approximately 29 years old.

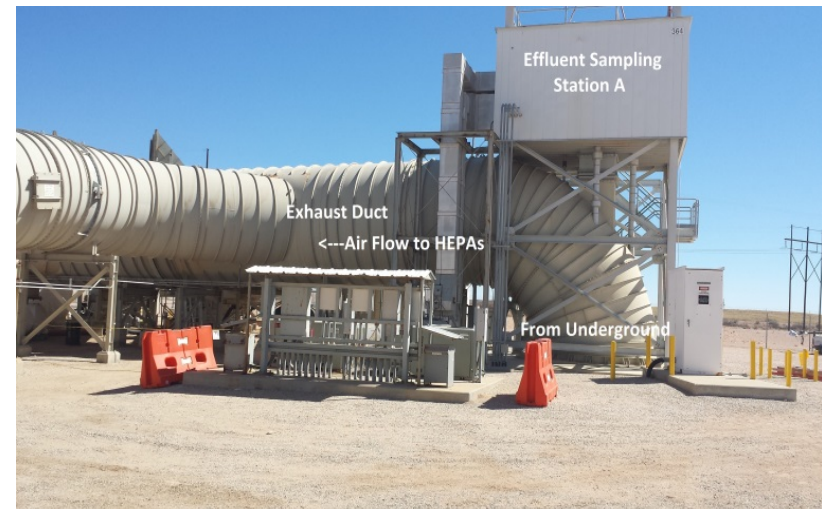
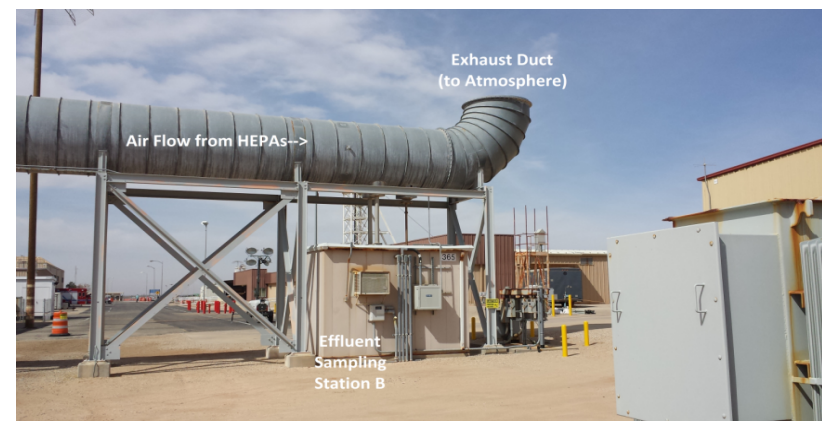
The Day After the Event

- On Saturday at 7:15 AM, February 15, the Radiological Controls Manager reported 4.4 million disintegrations per minute (dpm) alpha contamination on filters from effluent monitoring Station A upstream from the HEPAs and indicative of transuranics (TRU).
- Test results of filters from effluent monitoring Station B downstream from the HEPAs, and at the discharge to the atmosphere, were reported at 9:15 AM and indicated ~28 thousand dpm alpha and ~5.9 thousand beta contamination.
- Site Personnel were sheltered-in-place from 9:34 AM to 4:35 PM, then site access was restricted to essential personnel.

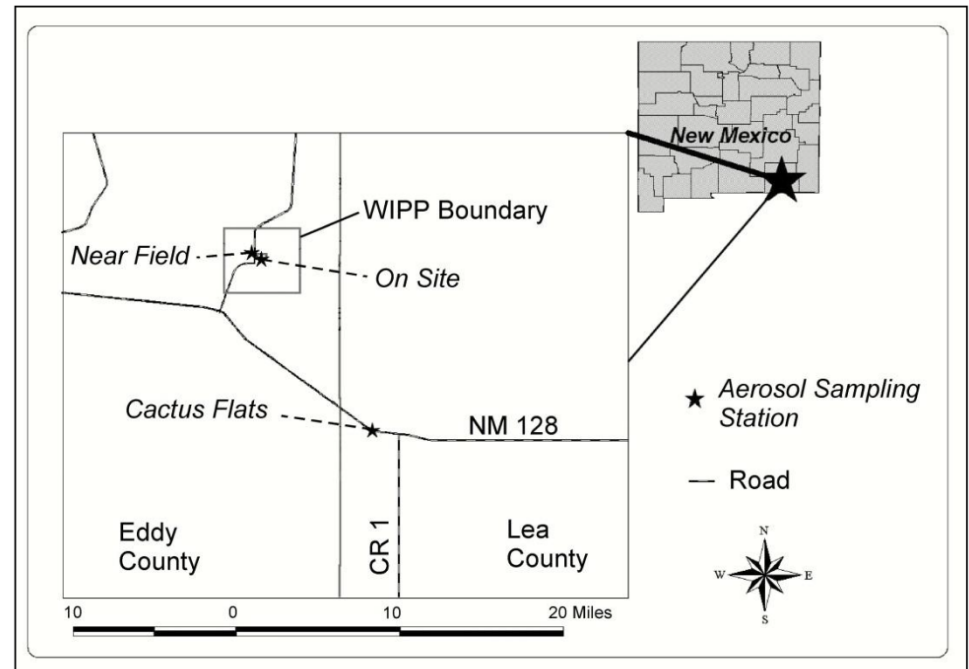
The Days Following

- On February 19, Carlsbad Environmental Monitoring and Research Center (CEMRC) reported radiological results from the CEMRC air sampling station located approximately 0.6 miles northwest of the site on the WIPP access road.
- The filter counted was installed at the station prior to the event (on Tuesday, February 11) and was removed on Sunday, February 16.
- The levels were higher than the normal background levels of radioactivity from transuranic elements commonly found at WIPP and indicated a small release of radioactive particles from the WIPP site.
